Just-In-Time Report

Mirror Safety

2007-RL-HNF-0051

Site/Facility: Hanford/All

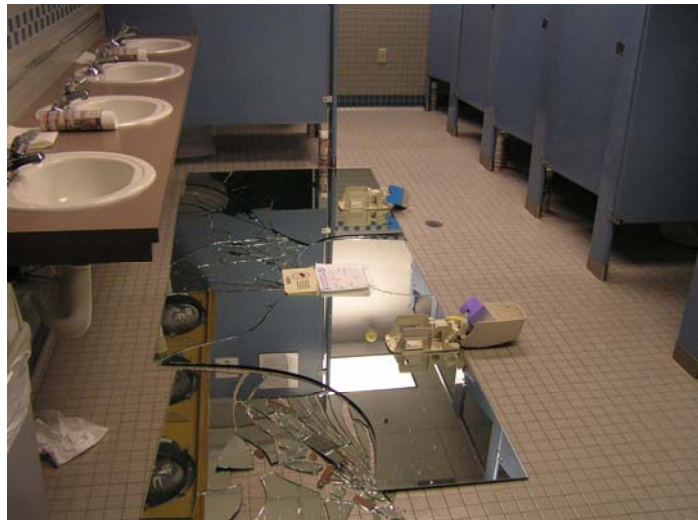
Event: On 12/17/2007 a mirror became detached from its supporting wall. The mirror was ~10' X 4'. It appears the glue may have been weakened by time or perhaps other environmental conditions (water marks showing a leak that ran down the wall from the ceiling). An employee was struck by the mirror and treated for trauma to the top of her head. The next day she experienced soreness to her head, neck, left shoulder/arm, and right side of her spine.

Contributors: Most heavy mirrors are attached to their supporting walls using a special bracket at the bottom to support their weight and then construction adhesive to hold it against the wall. However, construction adhesive does deteriorate over time or may be affected by environmental conditions which weaken its bonding ability. If the mirror was not installed with top supporting brackets an accident can happen.

Important Points: Mirrors, even if properly installed using standard practices, can become detached from their supporting walls. Inspections should be conducted to ensure both weight bearing and top support brackets are installed.

Managers/Supervisors	Workers
Inspect mirrors to ensure they possess both bottom and top supporting brackets. Periodically verify their integrity.	Report missing/loose supports or if a mirror appears to be coming loose from the wall to management.
